**NORTHERN
SEABROOK BEACH
COASTAL BEACH STUDY**

June 1995

Appledore Engineering, Inc.
600 State Street, Suite D
Portsmouth, New Hampshire 03801

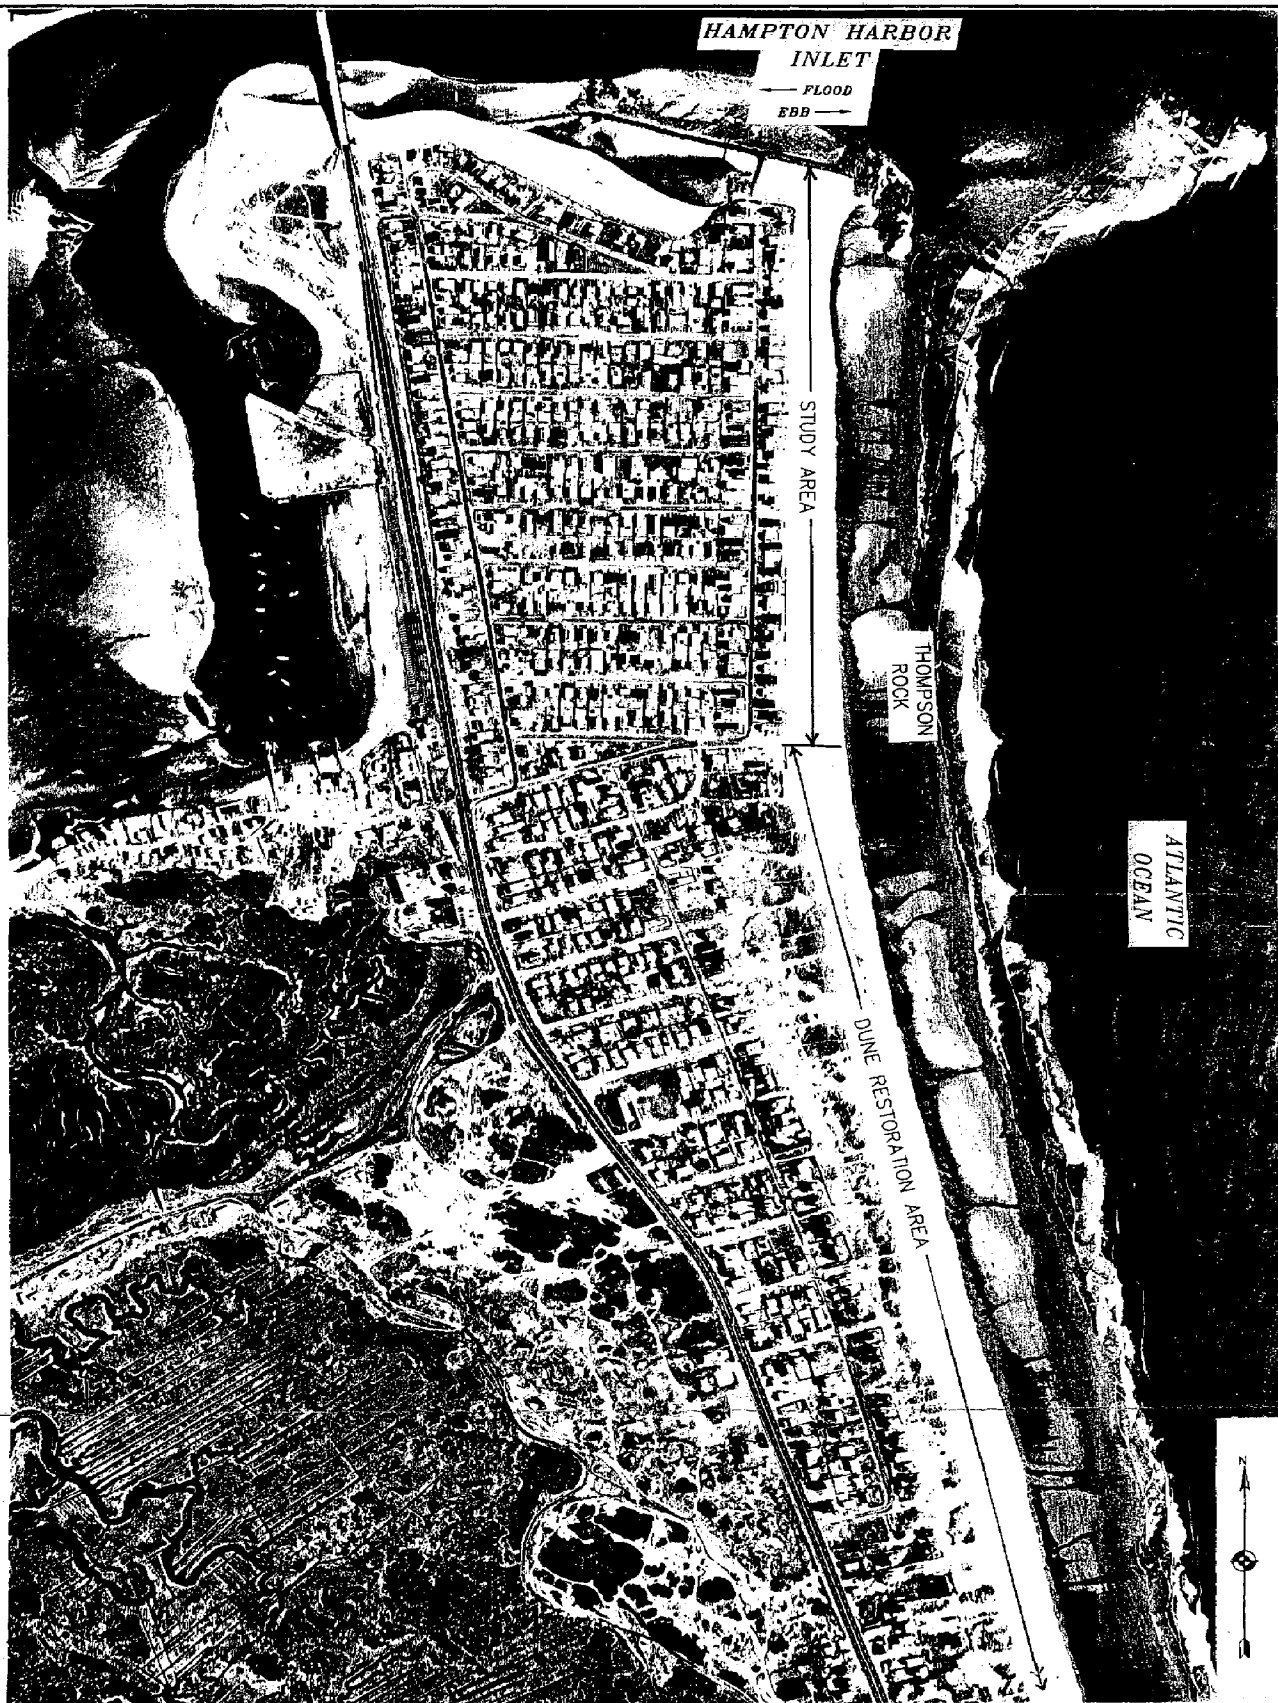
FIGURE 3

AERIAL PHOTOGRAPH MARCH 1986
